USARTL-TR-79-26

MODEL 540 ROTOR BLADE CRACK PROPAGATION
INVESTIGATION

August 1979

APPLIED TECHNOLOGY LABORATORY

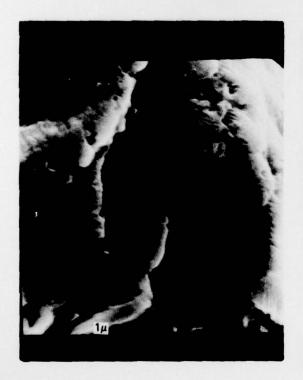
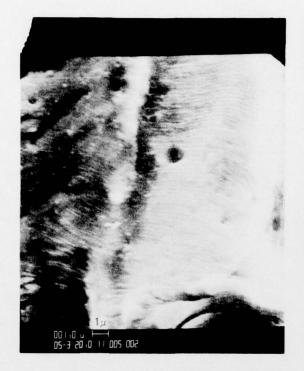
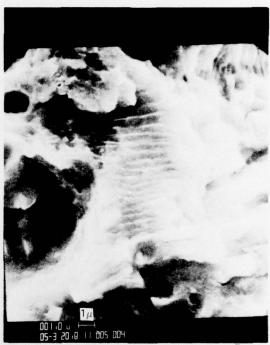
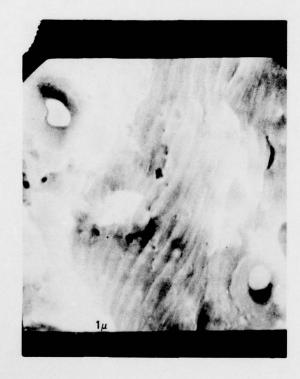
Direction of crack growth
